IStructE

ROUND 3

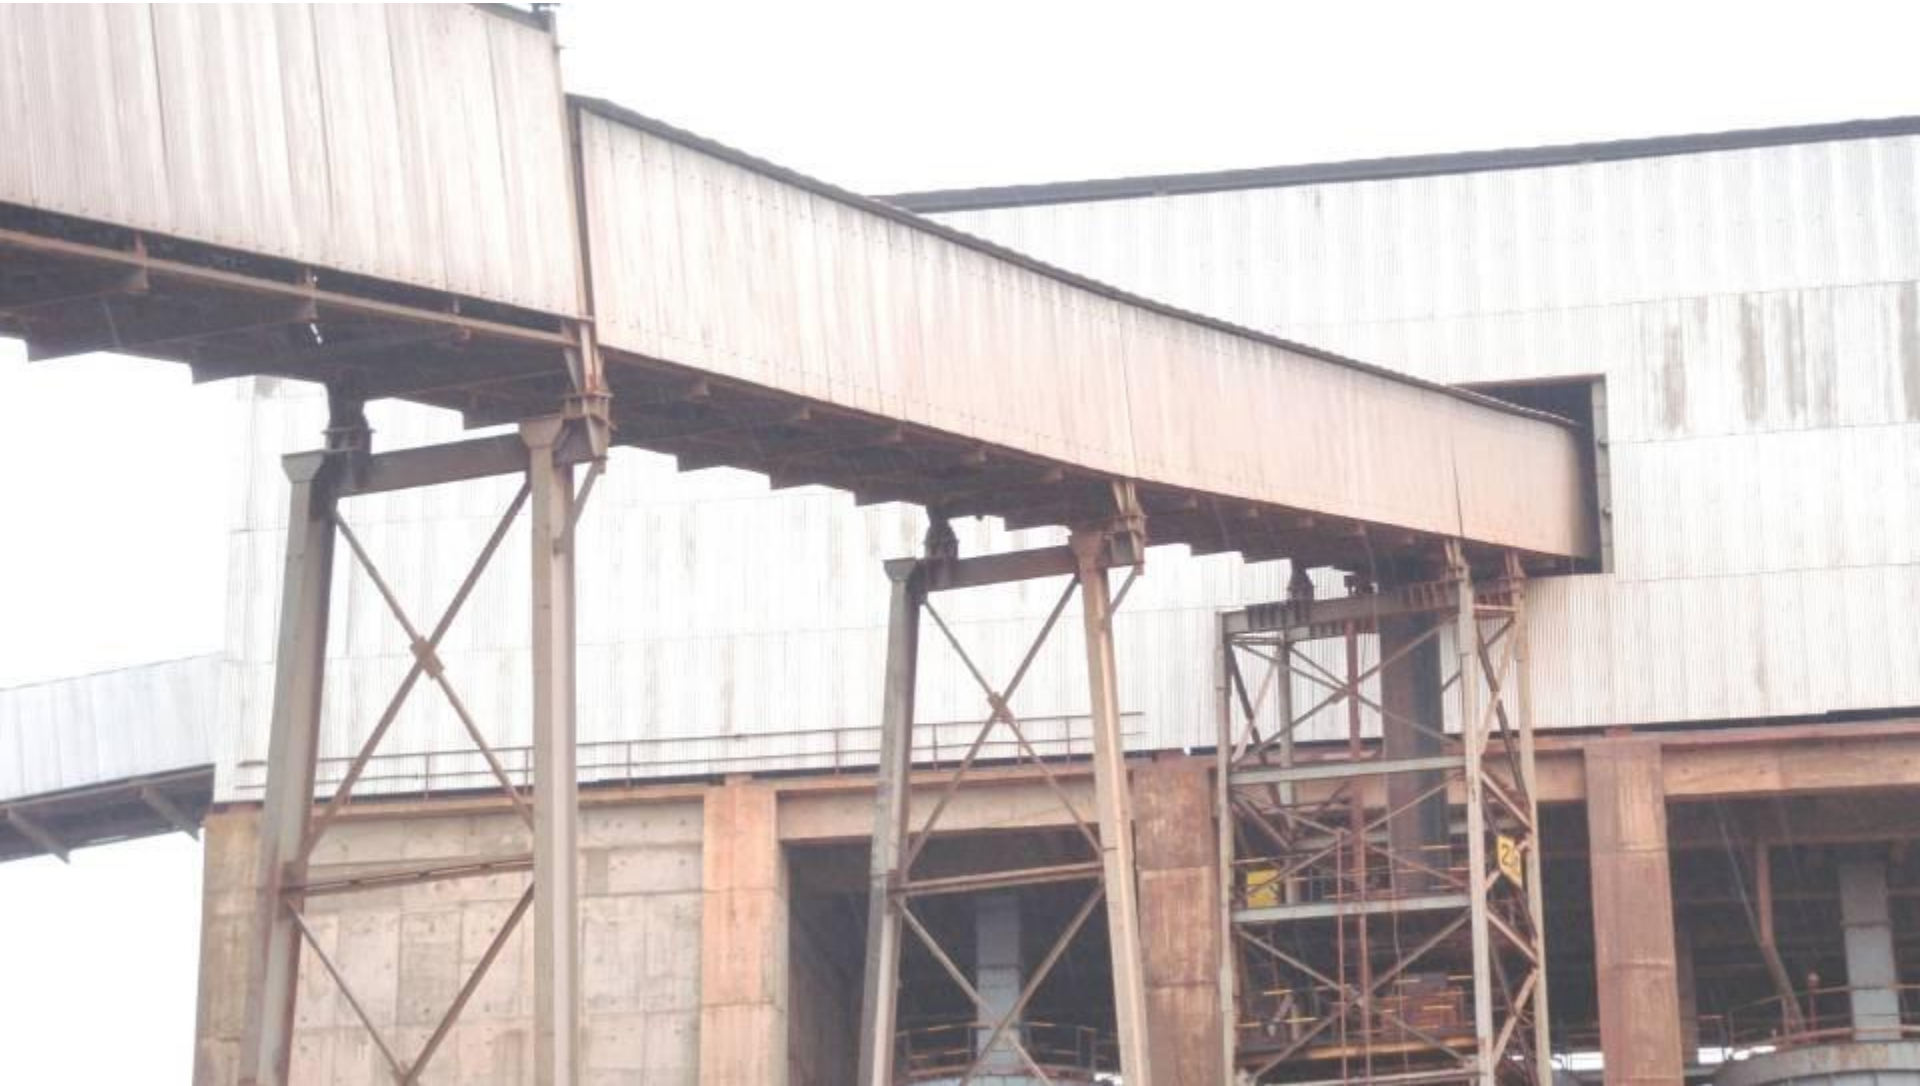
BCG, Cut beams provided as stiffeners are show above....
Identify the error. Hint : Loads

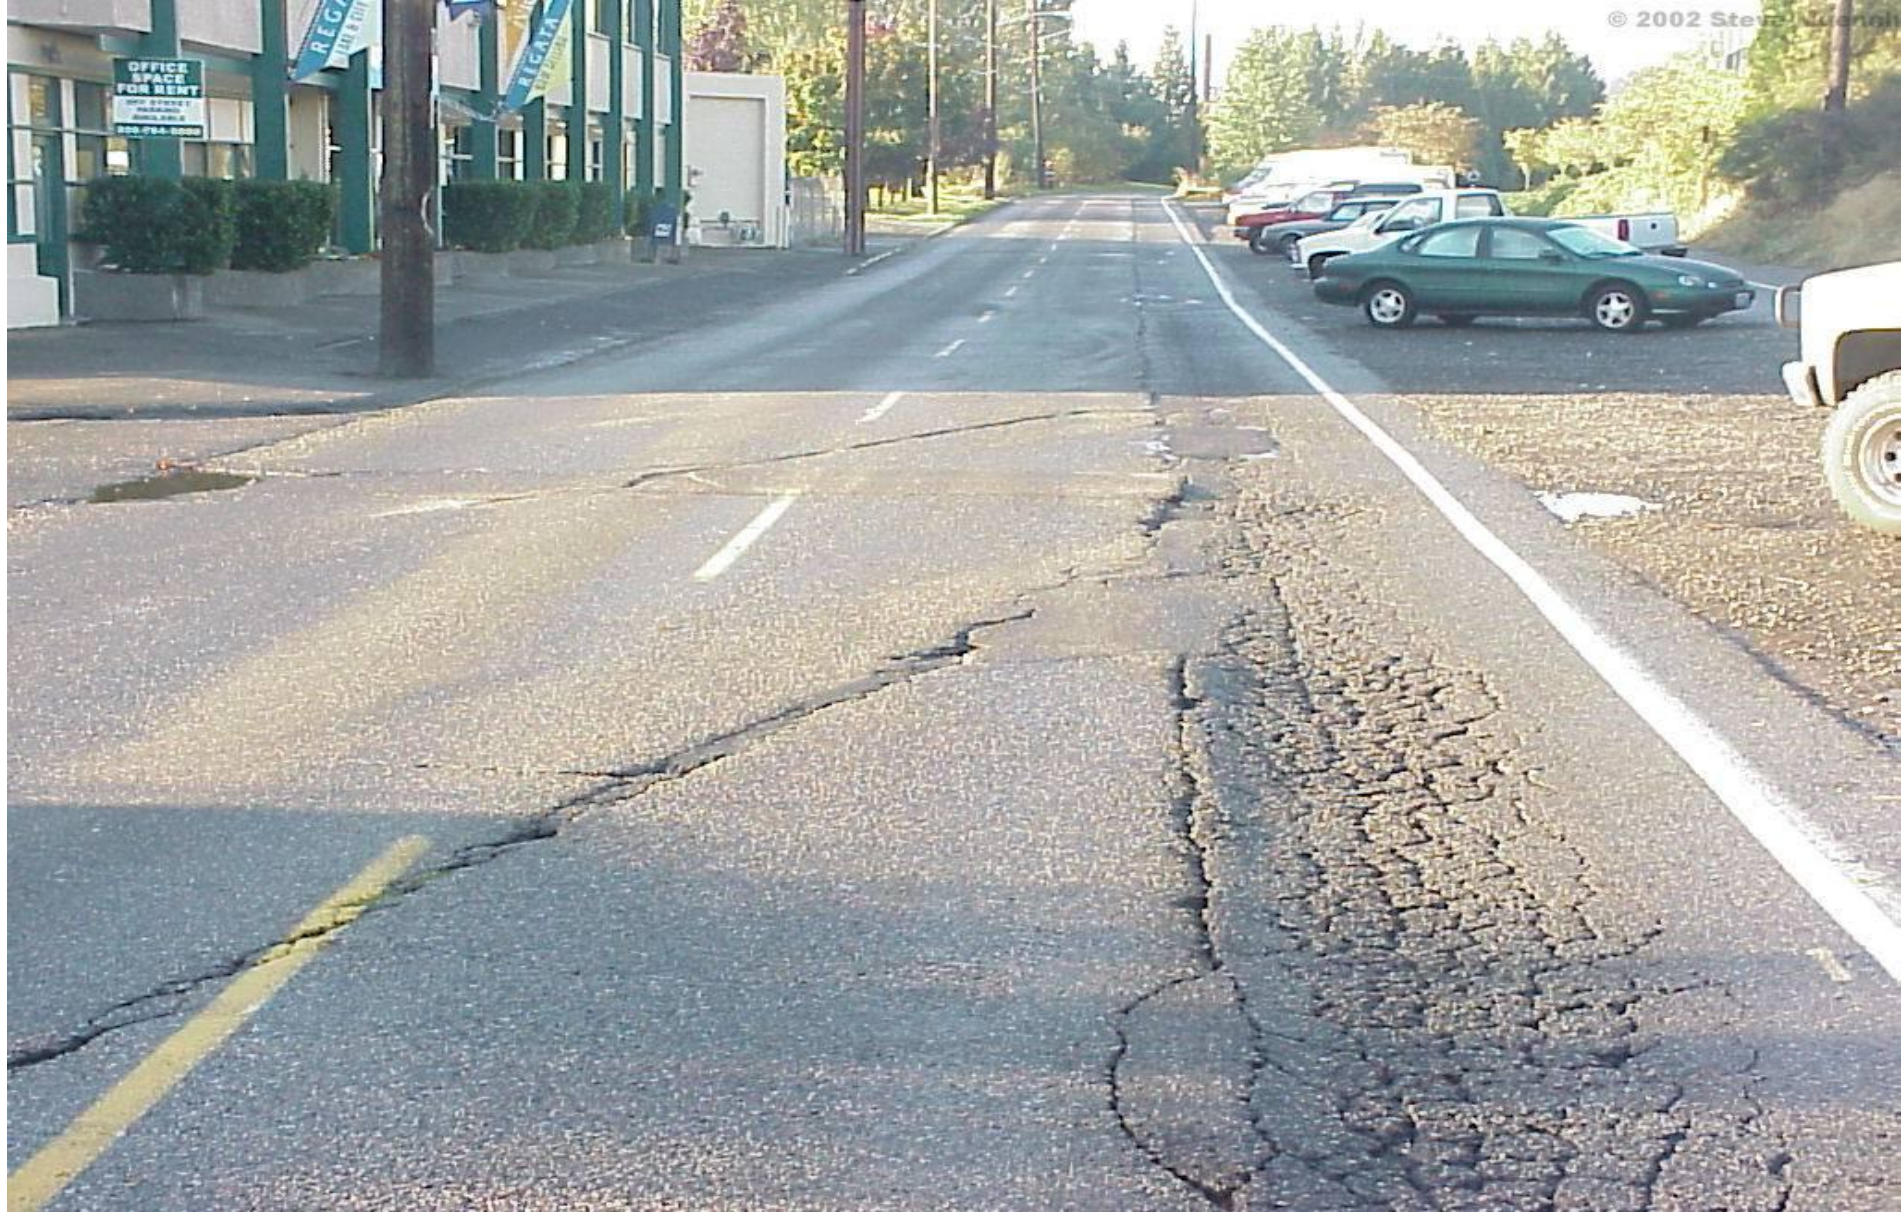
What is the above failure and why is it caused?

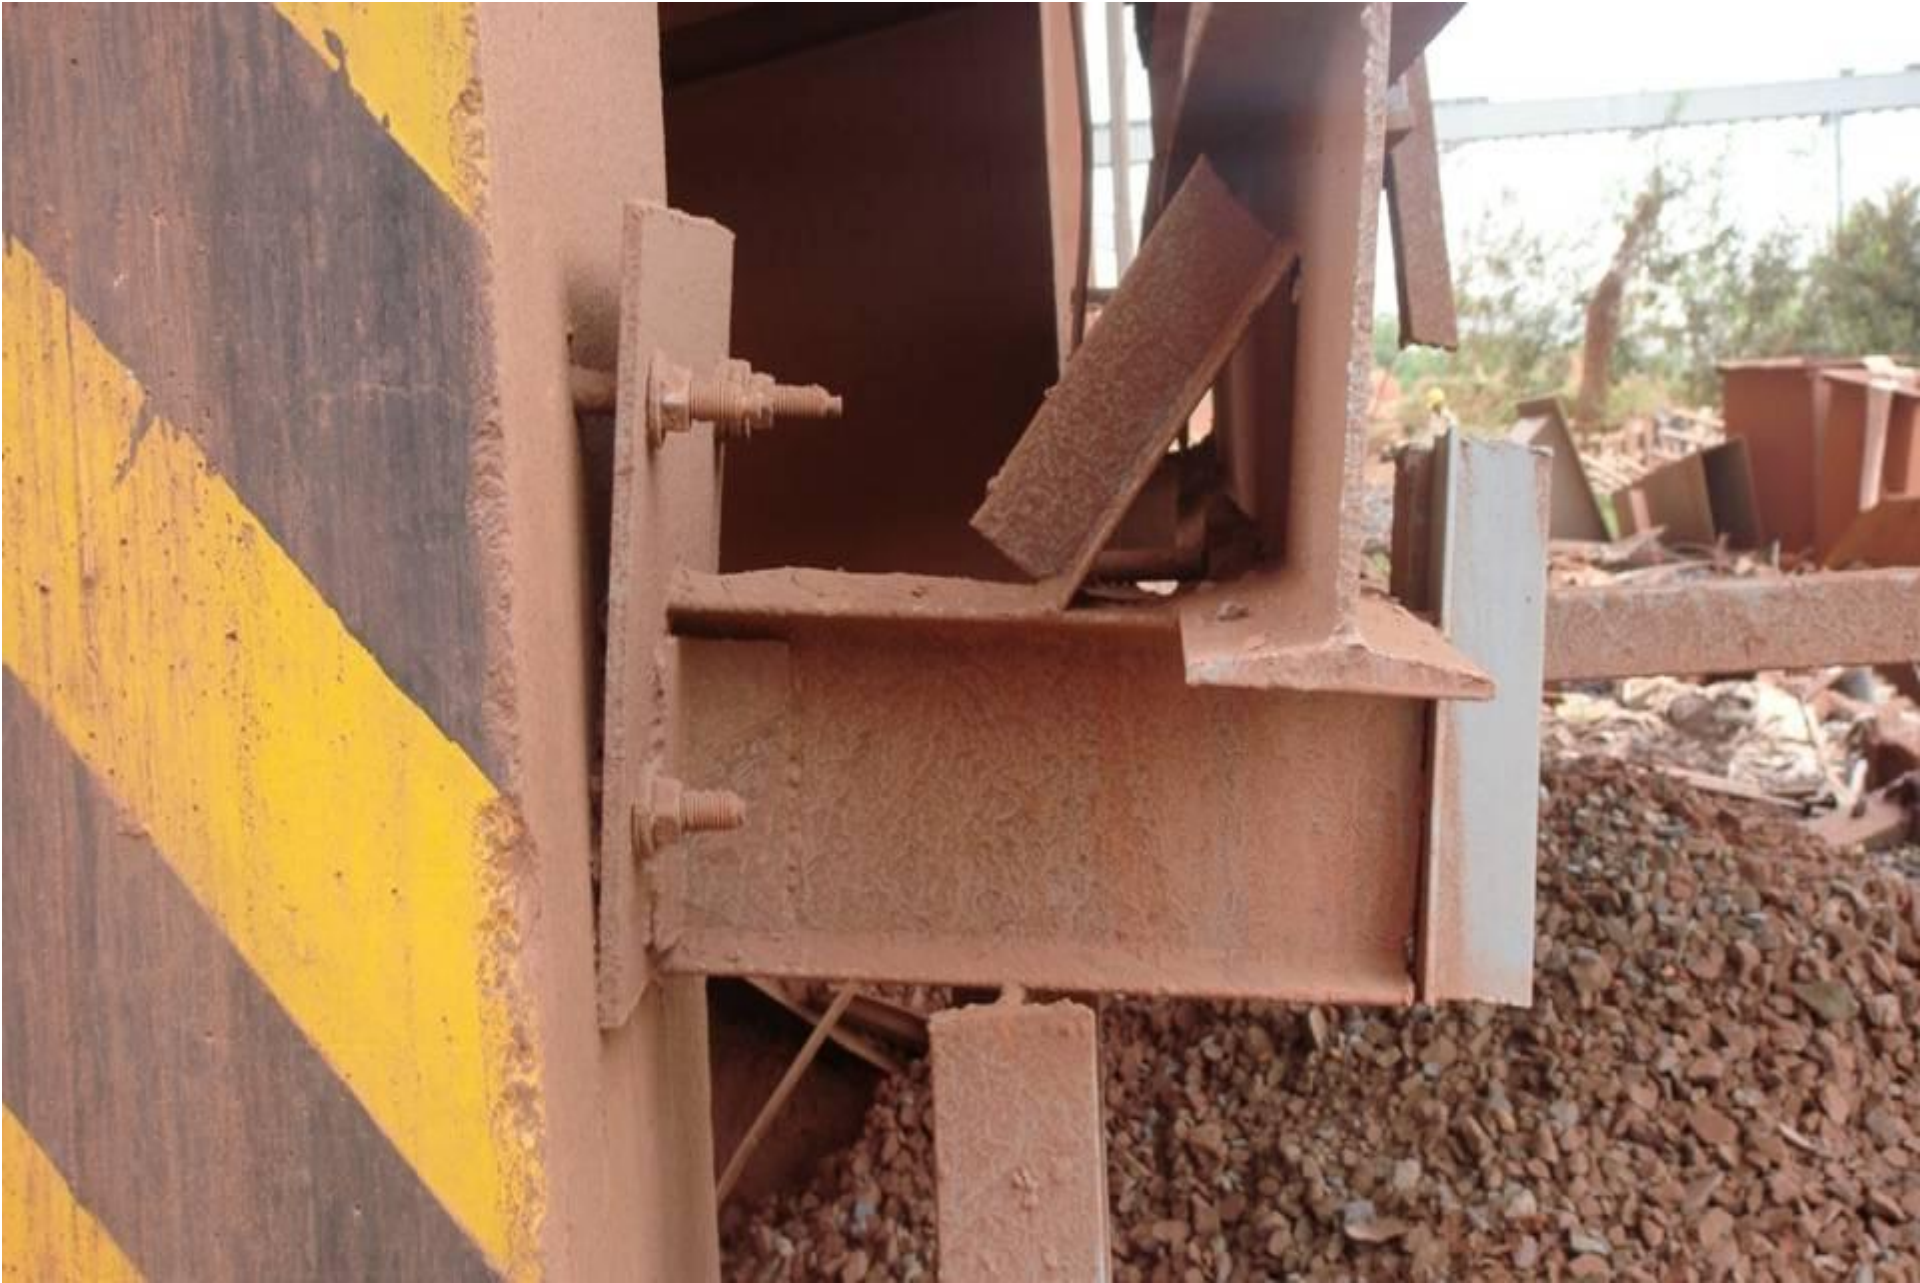
Identify the error in arrangement. Hint : Supports

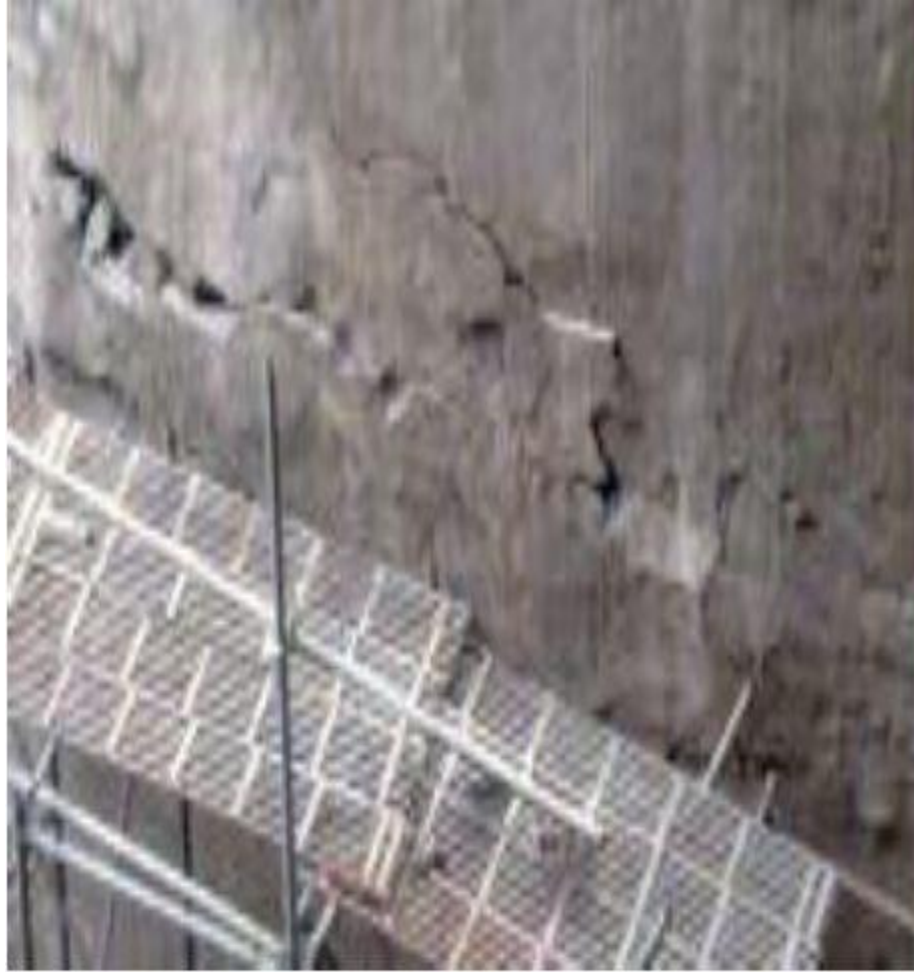
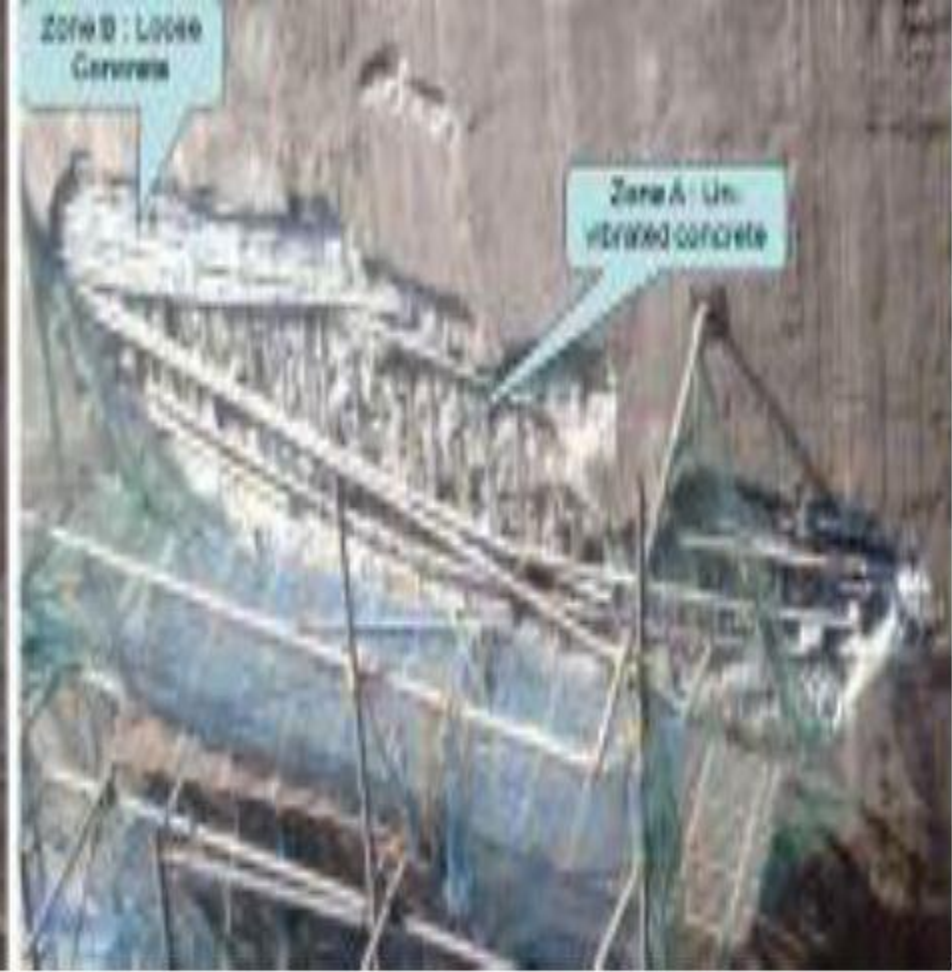
Silo wall crack before and after chipping the concrete.
Comment on the nature of the cracks.

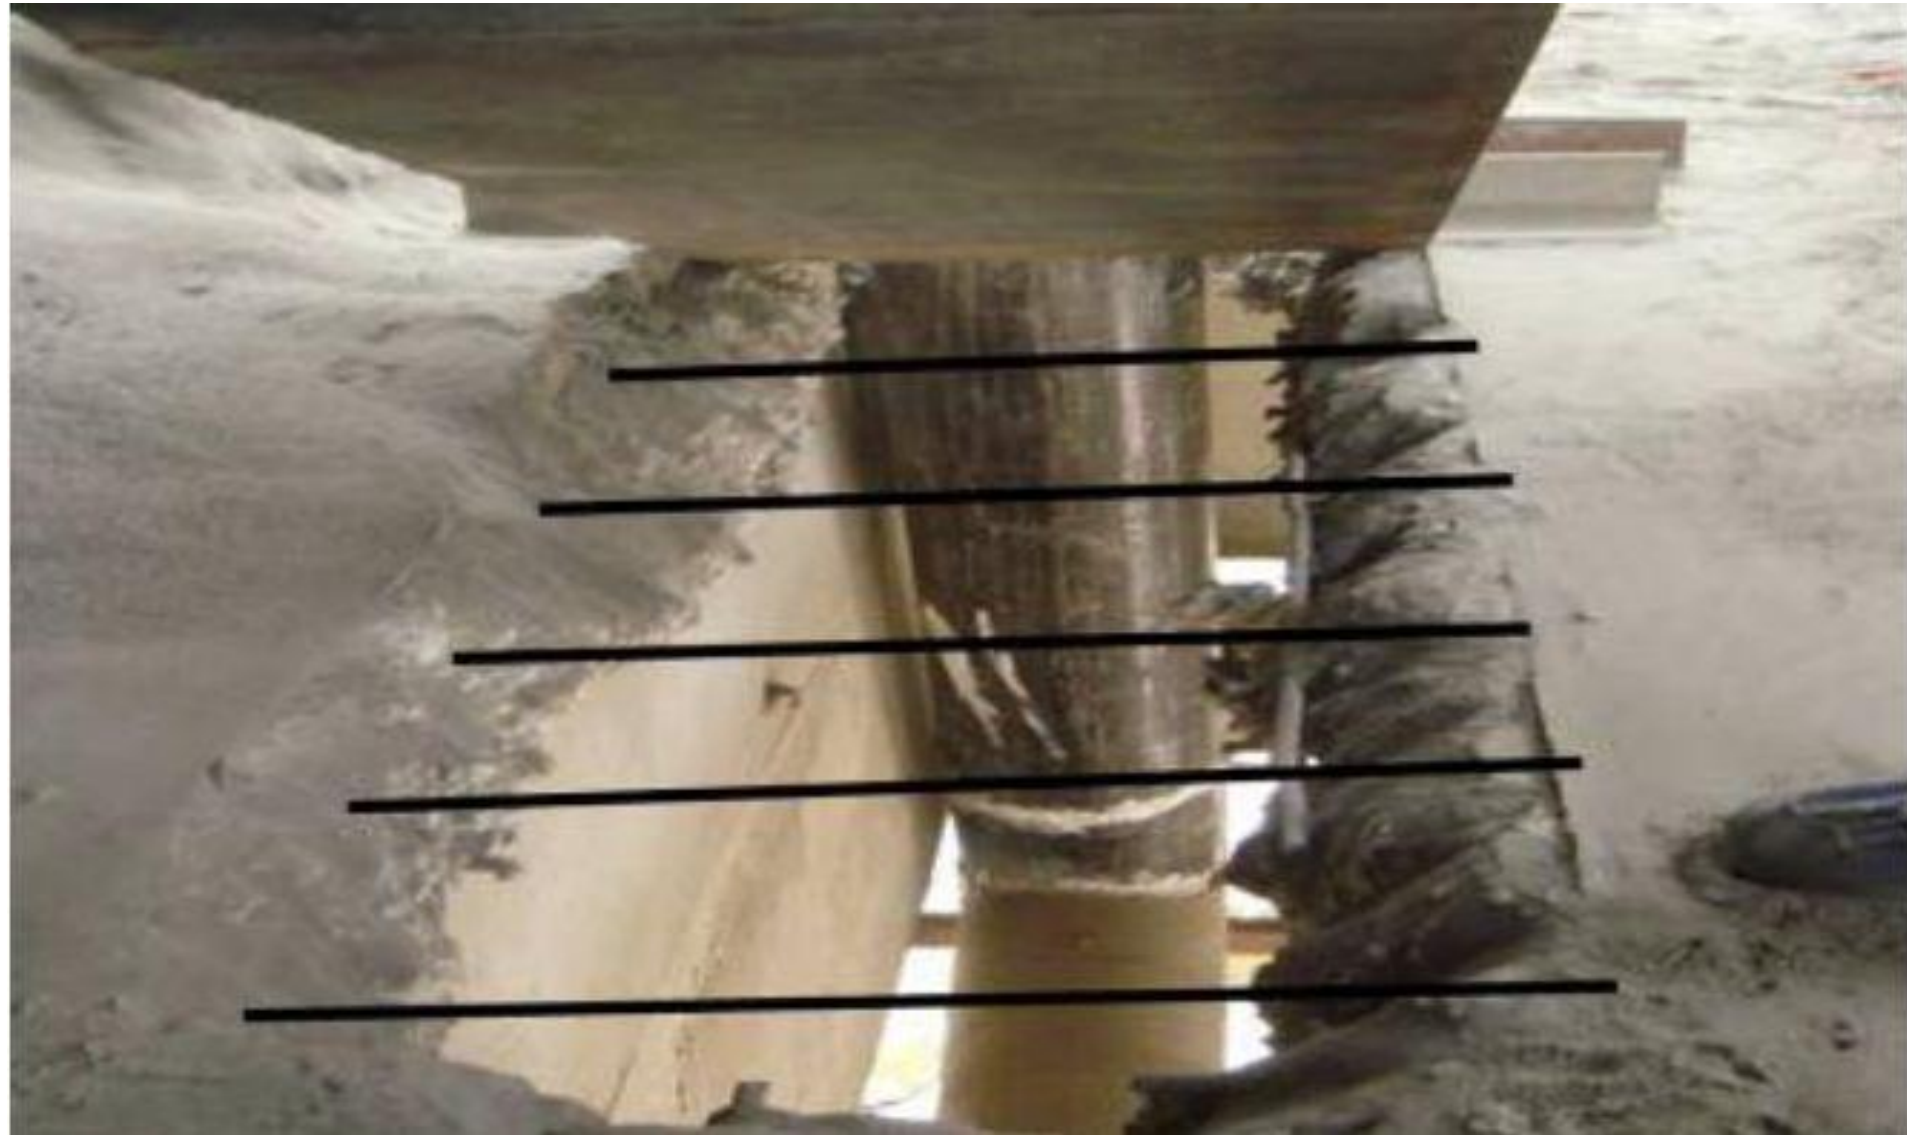
Slabs cut via cement mill
Can continuous slabs be cut? Suggest modifications.

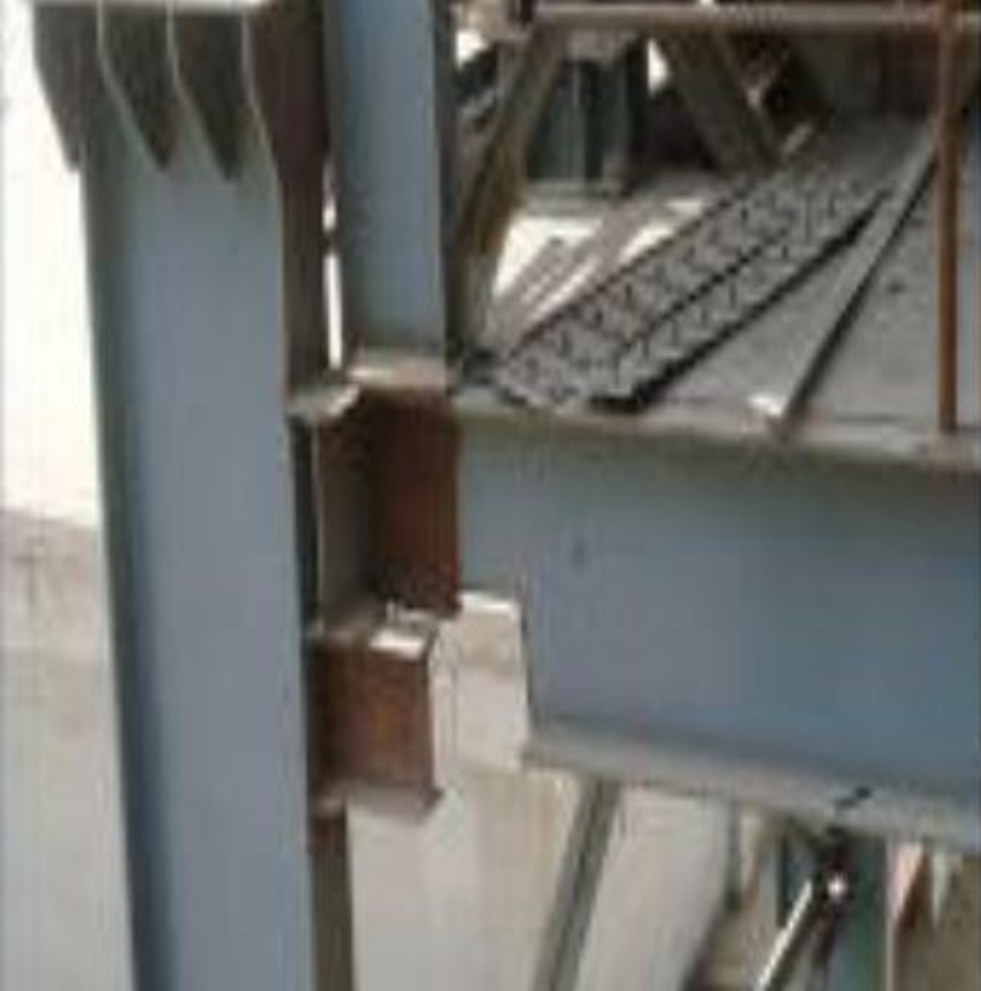
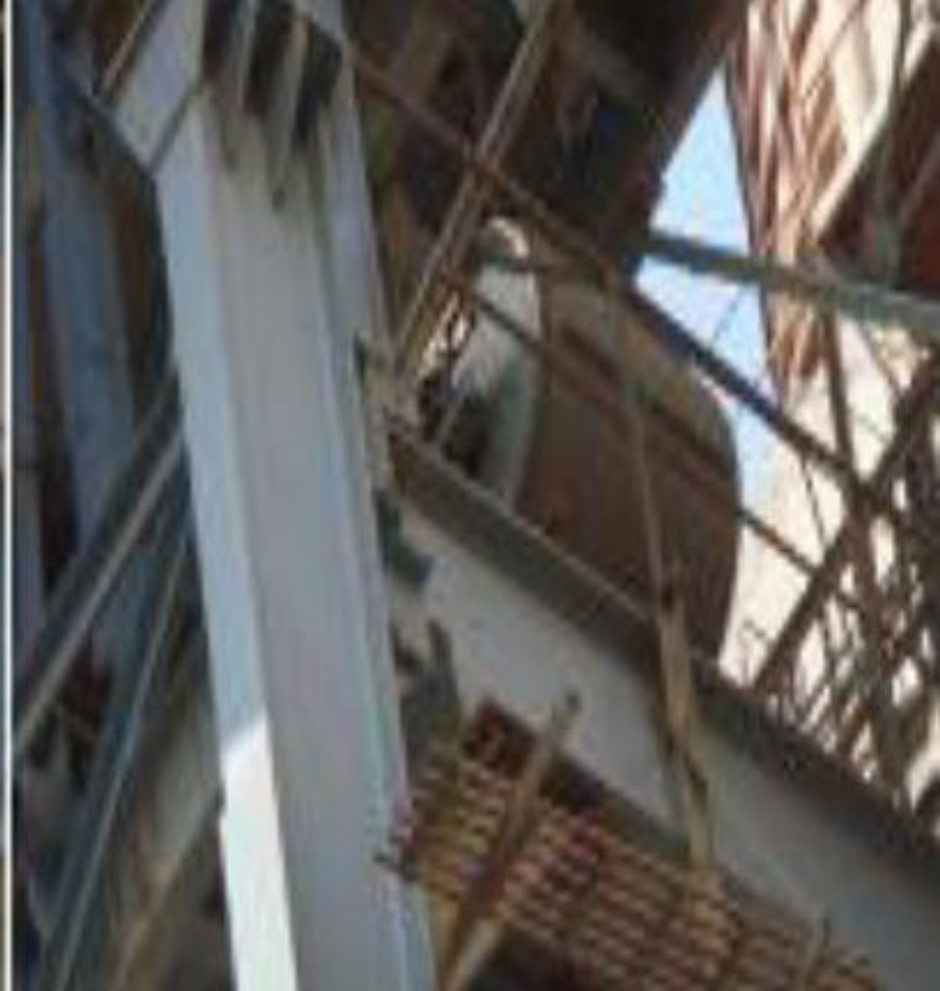
Cut ISMB provided as stiffener for strengthening
Explain the error in arrangement and how it can be modified?

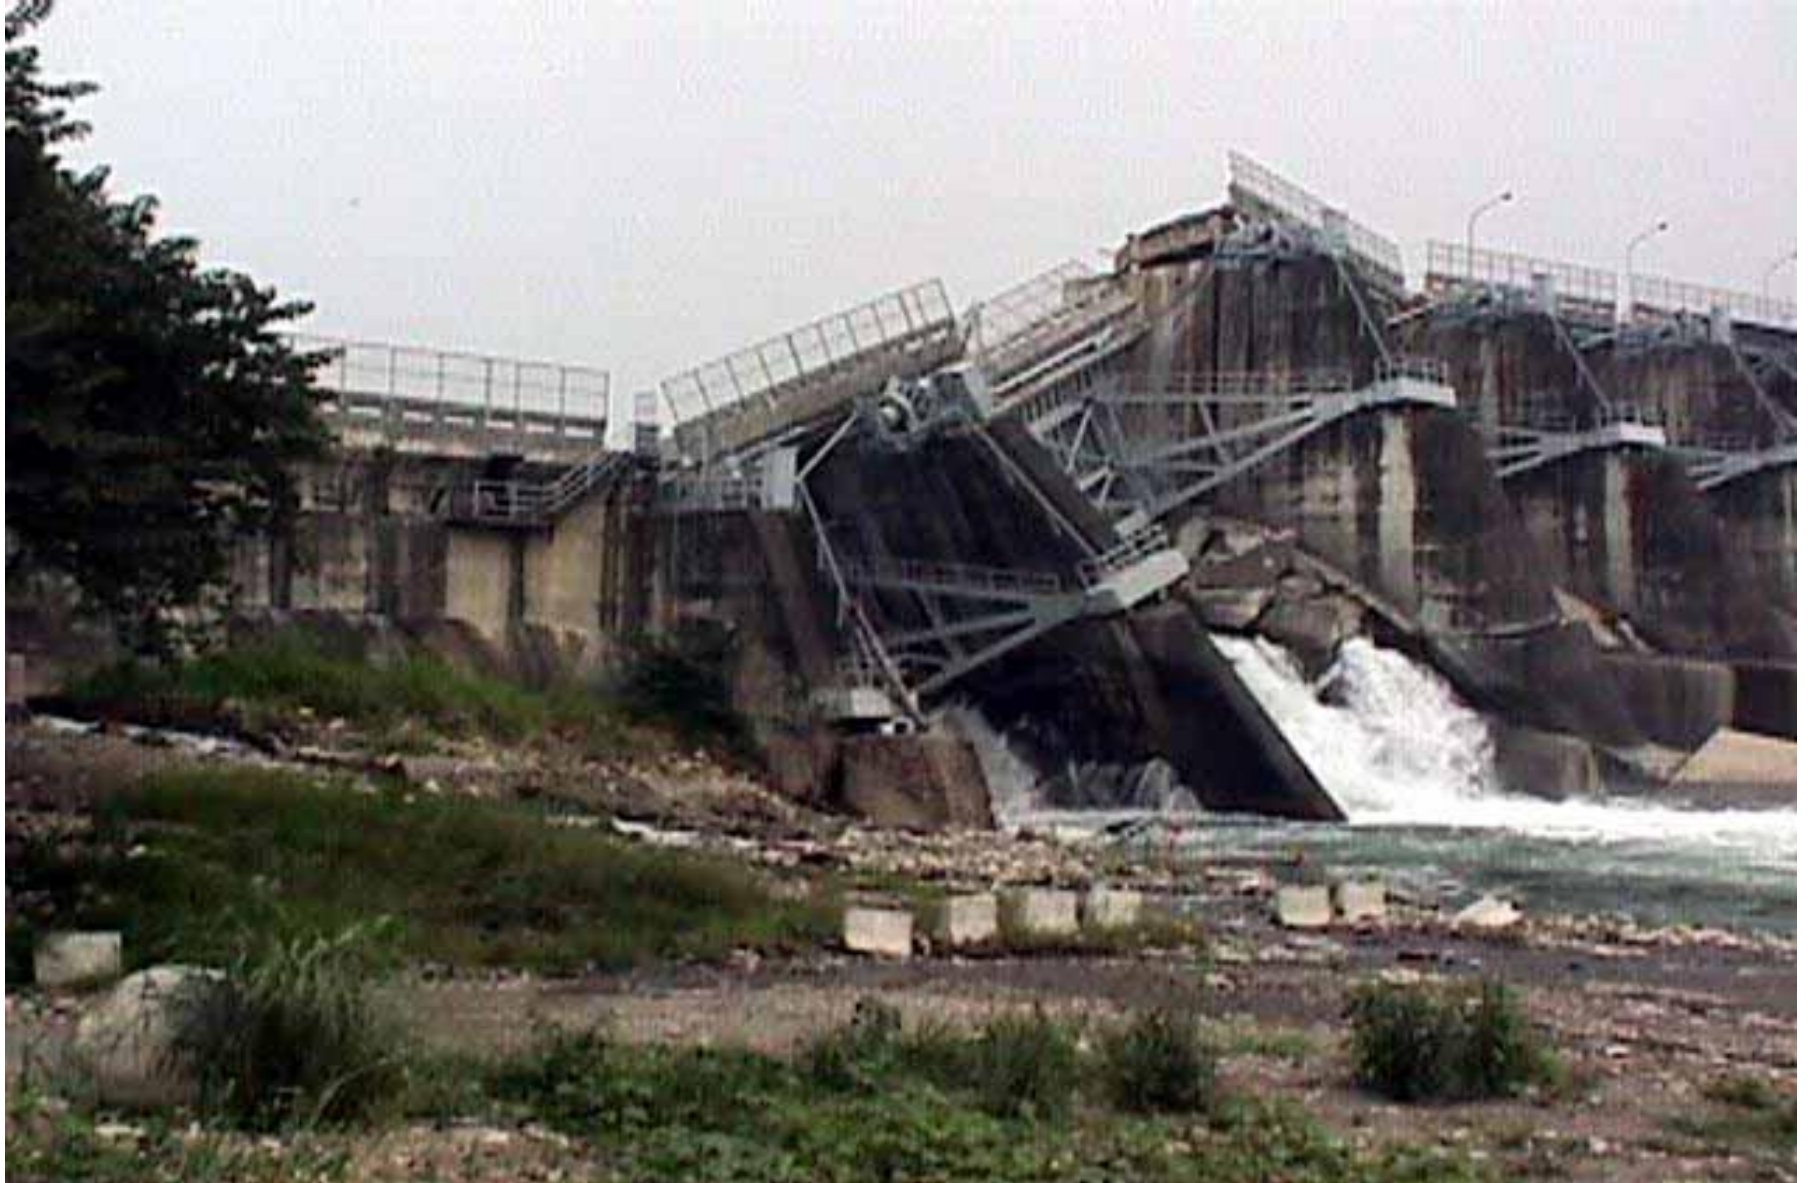
What type of failure is it and why did it take place?

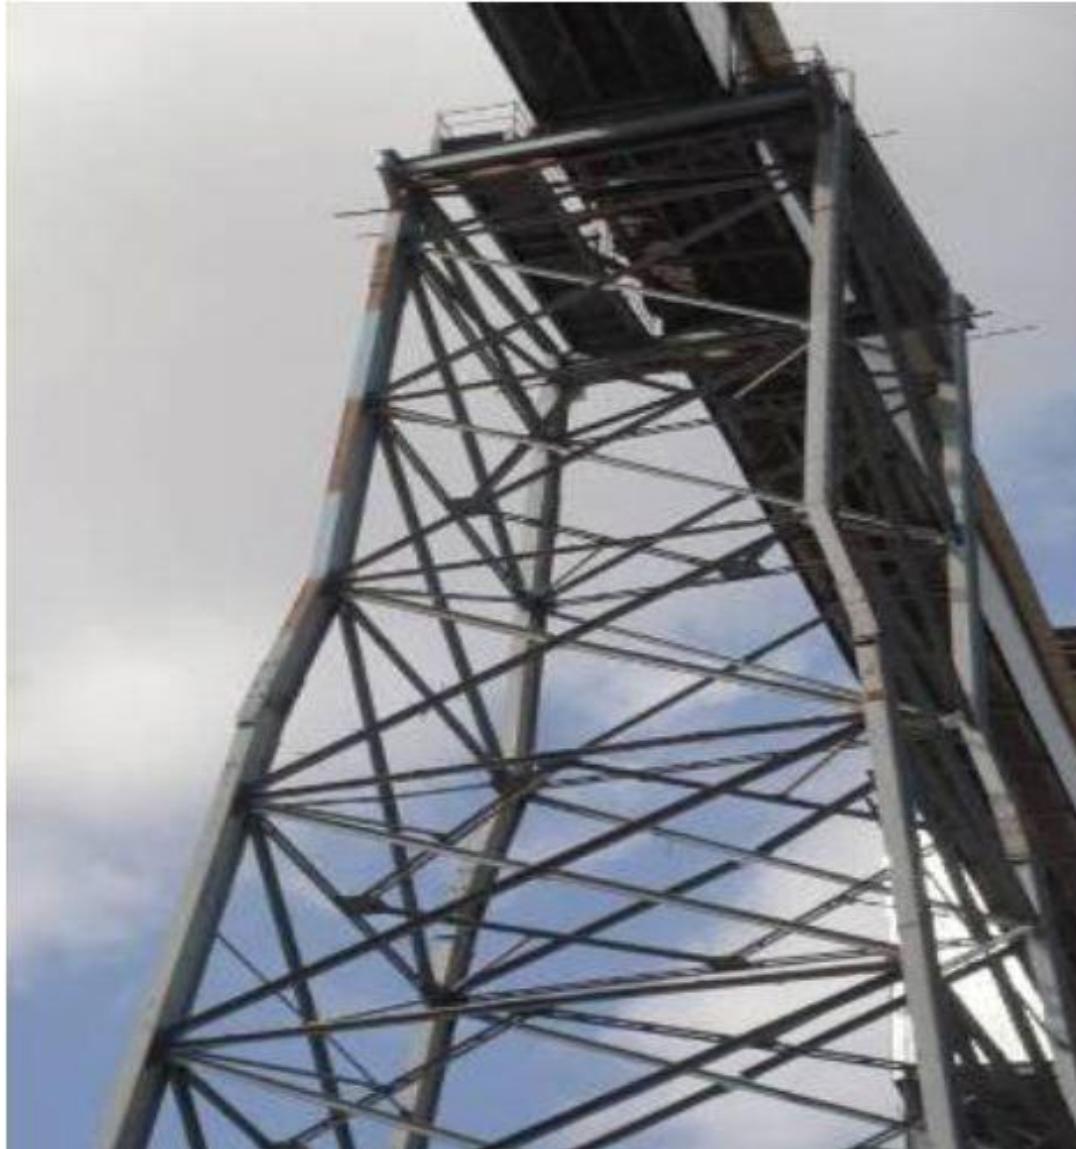
The trestle shown needs to have a uniform slope. How can the stability be ensured now? Hint: Identify the critical area.

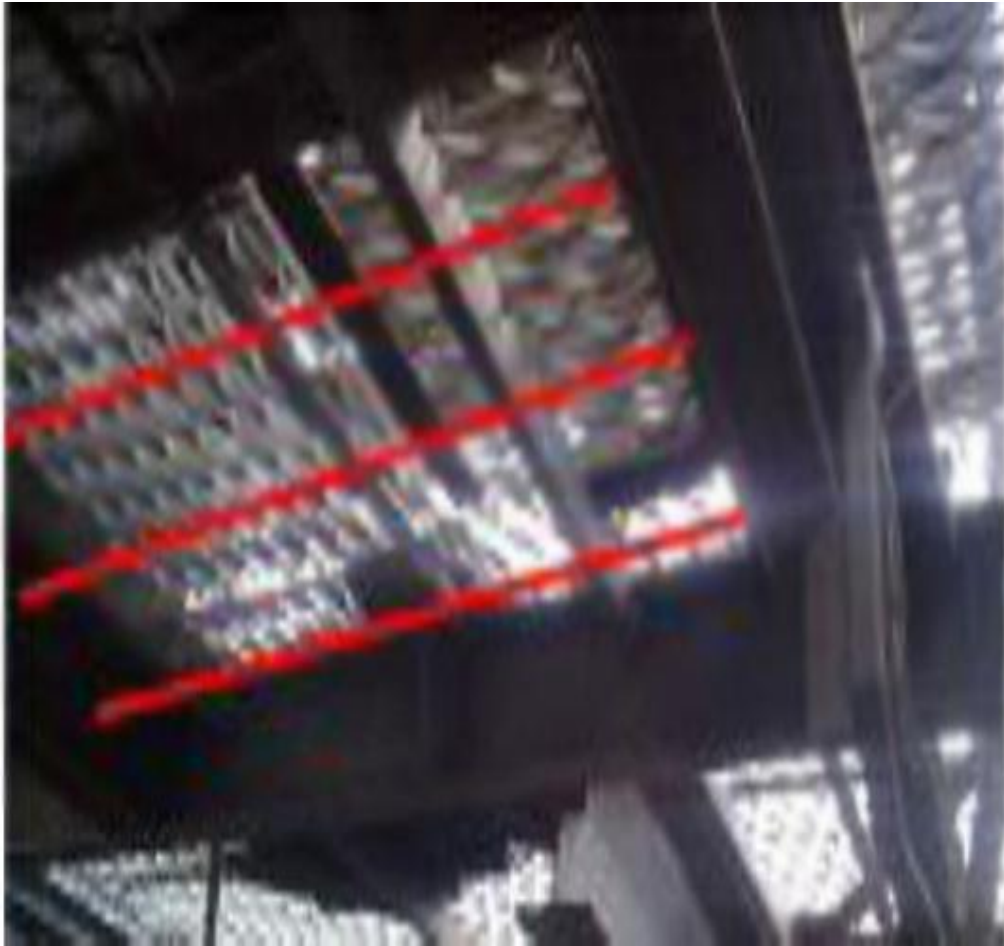
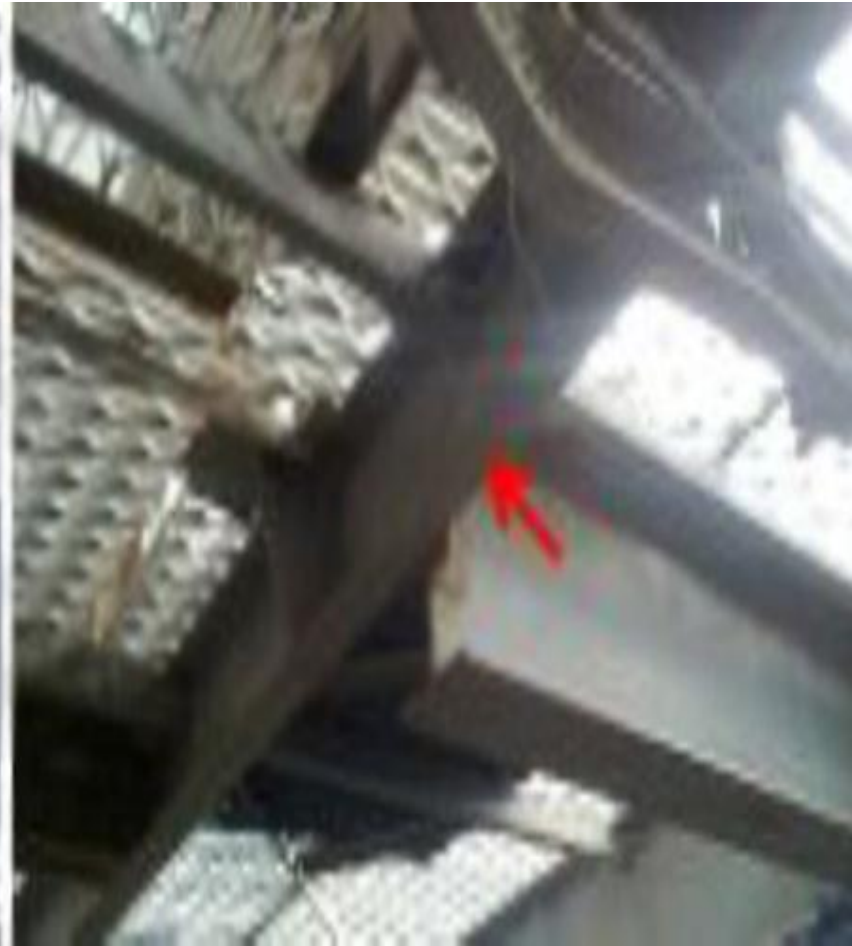
Structural Steel Tie beams are not to be erected in this manner. Explain how they should be fixed.
